# BUILDING ANALYSIS REPORT

*THE HOME INSPECTION FACTBOOK*

Address 600 Northside Drive

Date of inspection 8/1/05 Weather Conditions Clear Outside Temperature 86°F

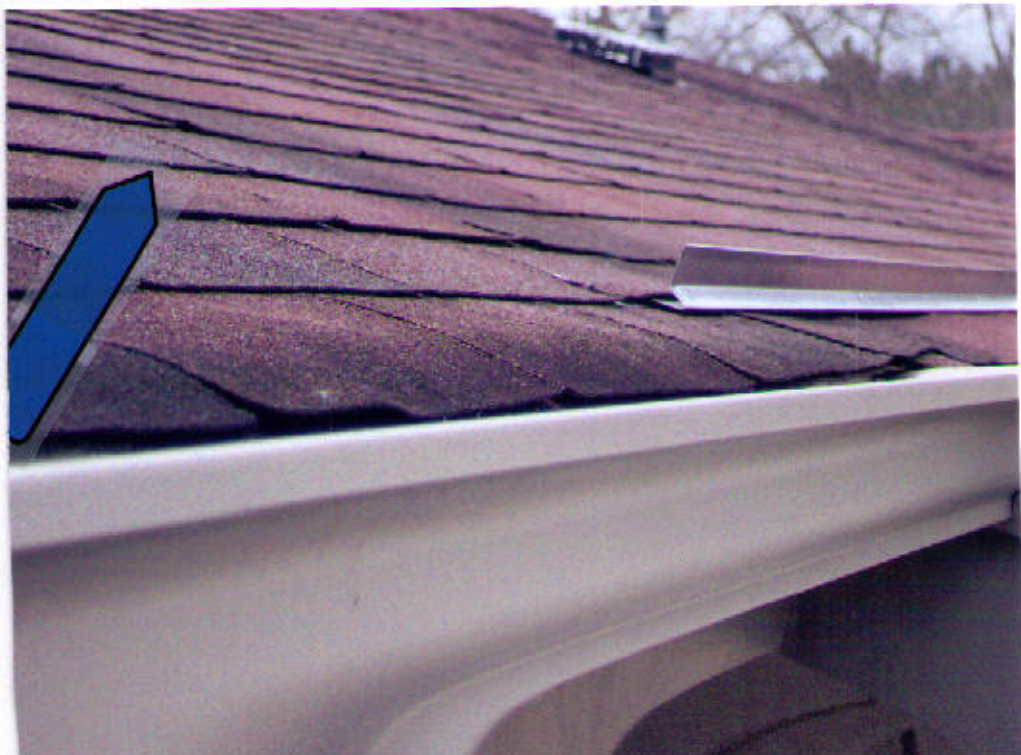
**Roof Covering:** The roof covering is made of fiberglass asphalt shingles. The roof looks good, but is showing signs of aging. In the photo below you can see the shingles are beginning to curl and become brittle.

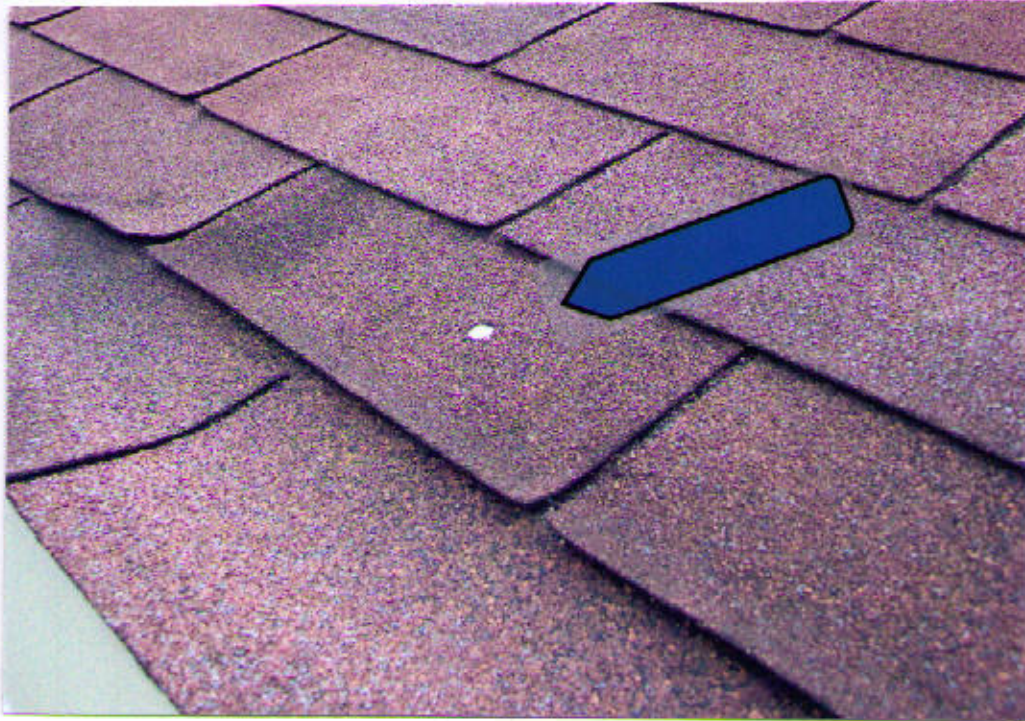
**Roof Covering (Continued):** The arrow in this photo indicates nail holes in the shingles that have been caulked. There are also other areas on the roof where nails are beginning to push through the shingles. With the roof being 18 years old, I feel it has served its purpose and should be replaced.

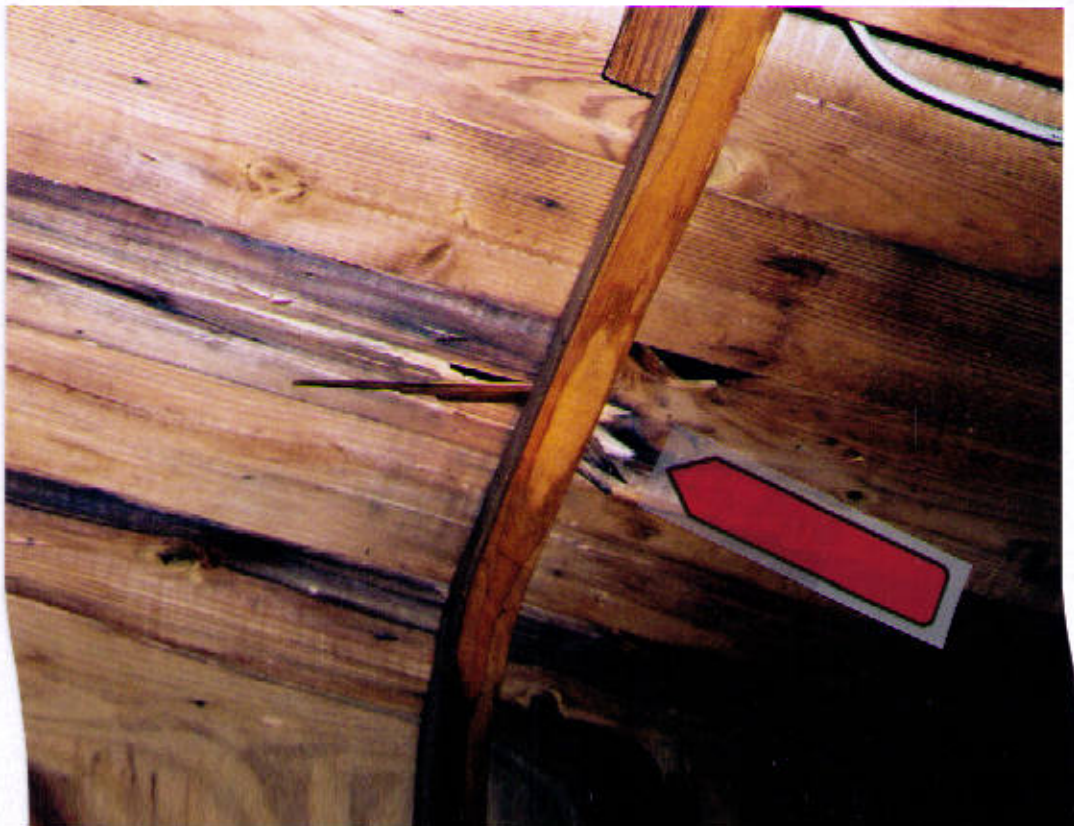
**Roof Leaks:** This photo was taken in the attic of the house. The arrow points to roof decking with wood rot caused by the leaking roof. Damaged areas need repair as the new roof is being replaced.

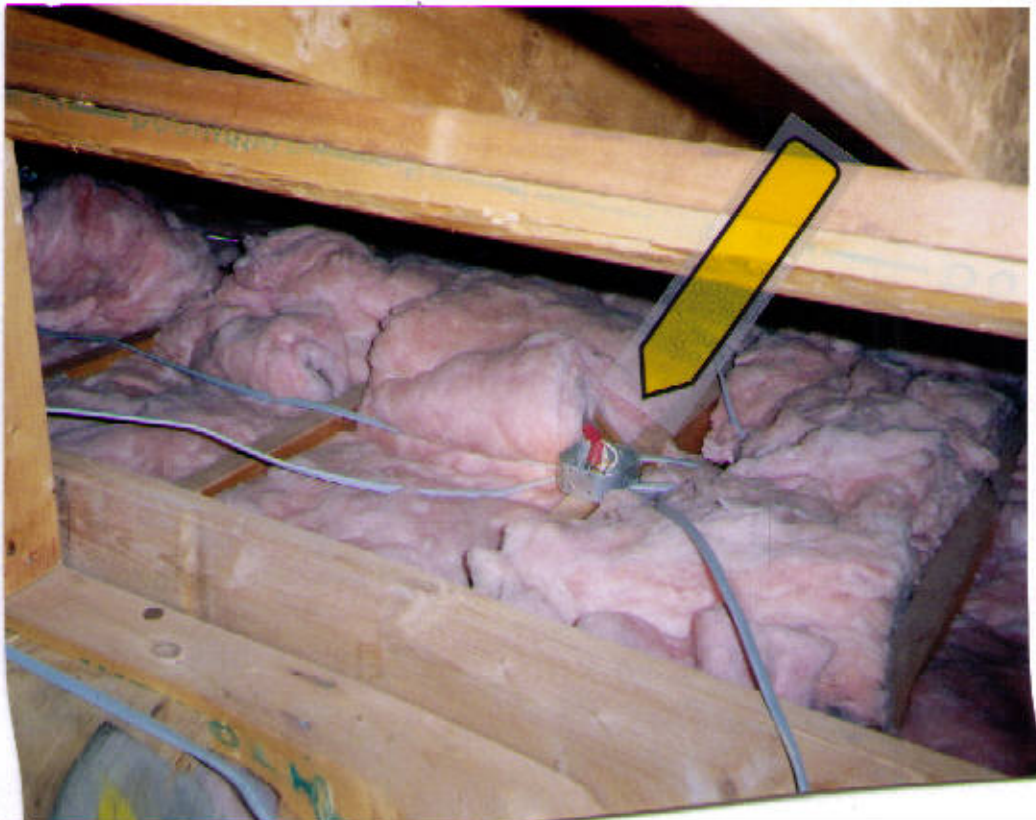
**Circuits:** There are several problems found with the electrical wiring in the attic. These problems are shown in the following pictures. I recommend that a trusted and licensed electrician make all the repairs. The arrow in the photo below points to a junction box that has no cover. The purpose of the cover is to contain a fire if this connection overheats.

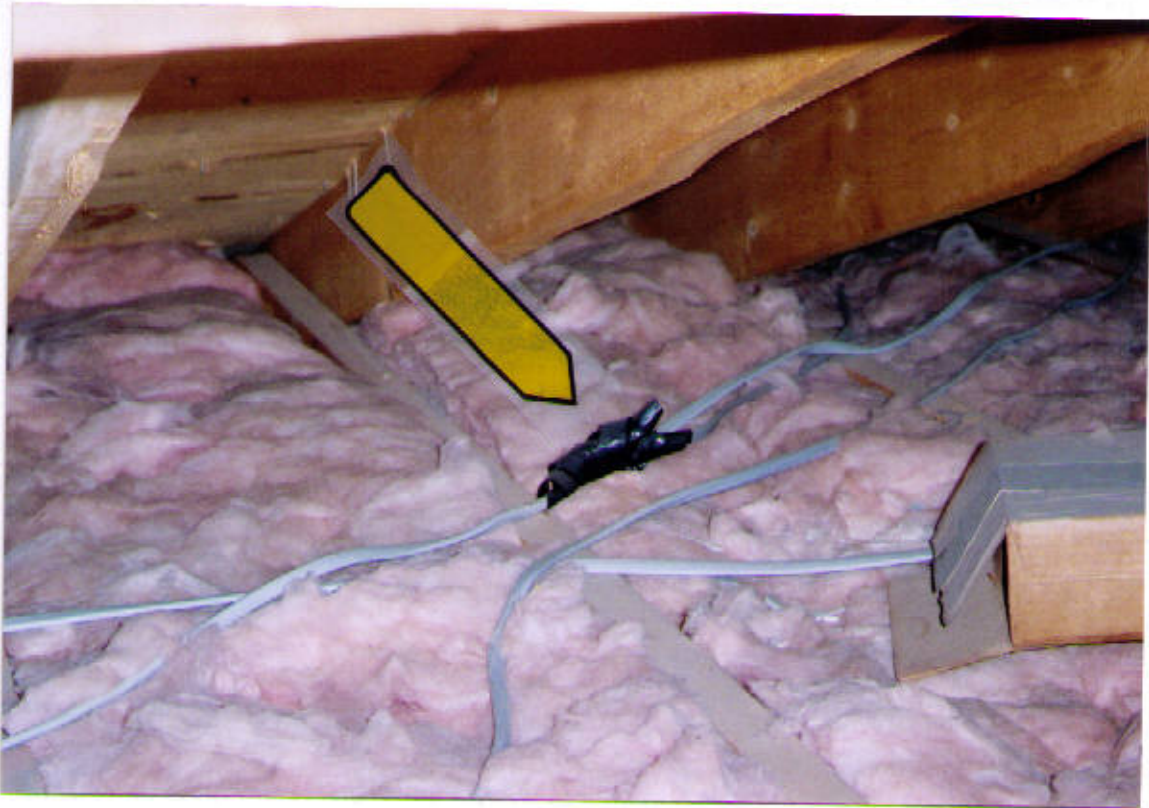
**Circuits (Continued):** The arrow in this photo points to a wire splice that should be enclosed in a junction box. Splices without junction boxes are a definite fire hazard.

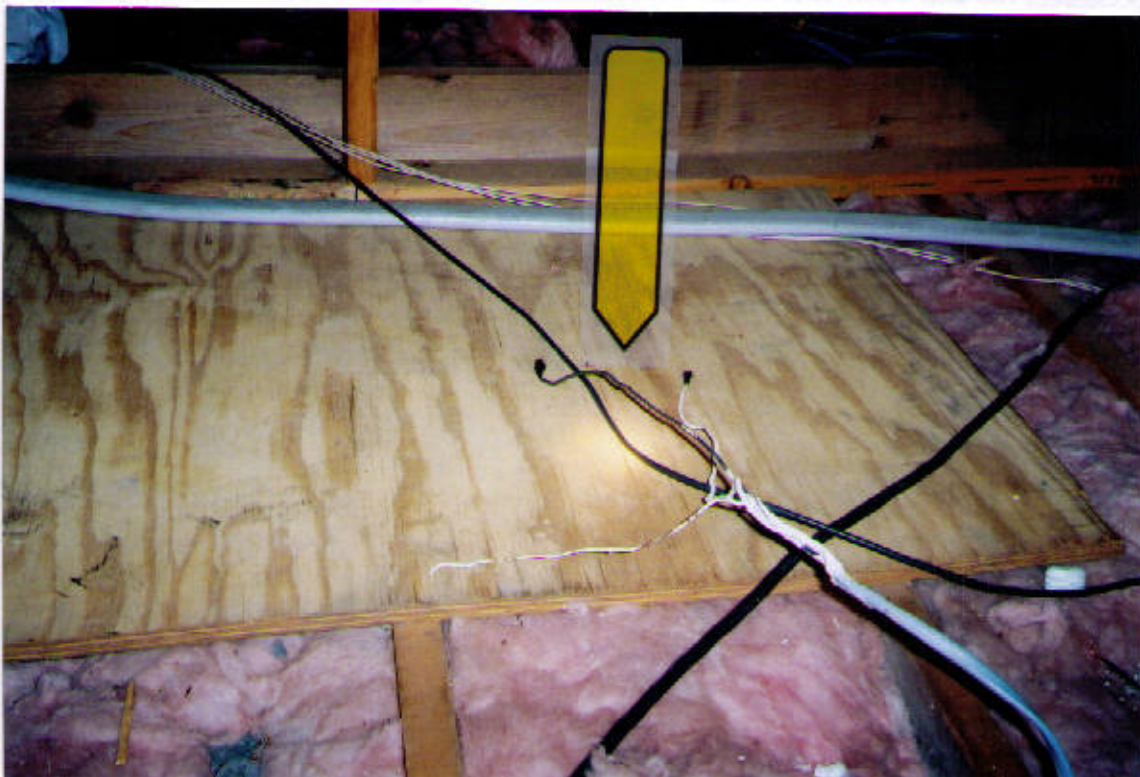
The arrow in this photo points to wire ends that should be capped and placed in a junction box. These wires have power and are a certain safety and fire hazard.
